**FULL-SCALE DYNAMIC CRASH TEST
OF A
DOUGLAS DC-7 AIRCRAFT**

TECHNICAL REPORT

by
W. H. Reed
S. H. Robertson
L. W. T. Weinberg
L. H. Tyndall

**Aviation Safety Engineering and Research
Division of Flight Safety Foundation, Inc.
Phoenix, Arizona**

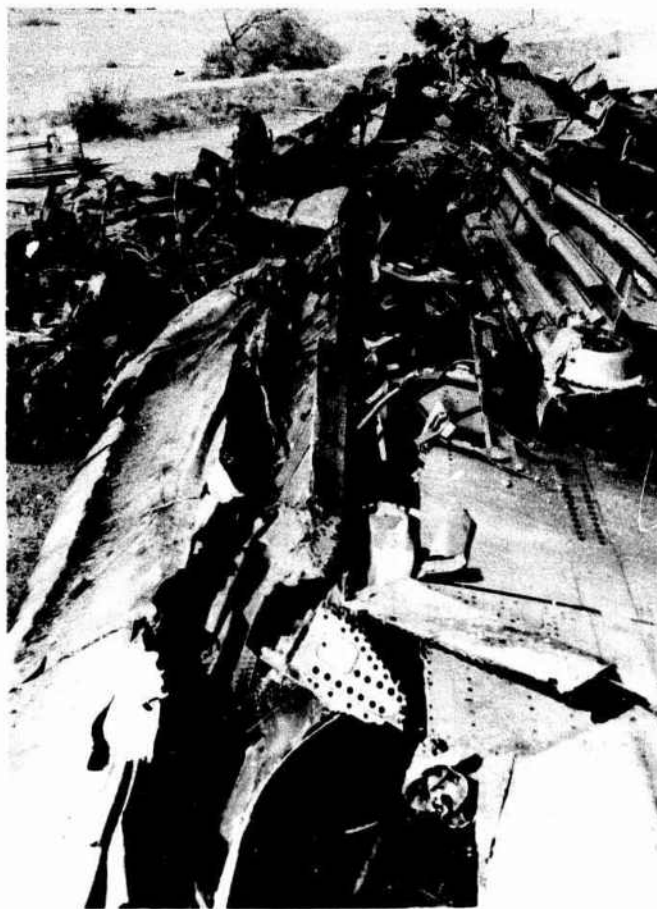
FIG. 34 CLOSEUP VIEW OF FRONT OF LEFT MID-WING
AREA (ALTERNATE TANK NO. 1) WHERE GELLED
FUEL WAS CARRIED

The bottom of No. 1 alternate tank had no visible punctures and was only slightly deformed. The top was in good condition with practically no deformation. The spar leading edge area separated for 28 inches, outboard to inboard, on the bottom and completely separated on top. This is shown in Figure 33. Just outboard from the No. 1 engine, the forward spar was bulged outward (forward). The arc formed in the spar between the top and the bottom edges had a radius of approximately 30 to 35 inches. This is shown in Figure 34.

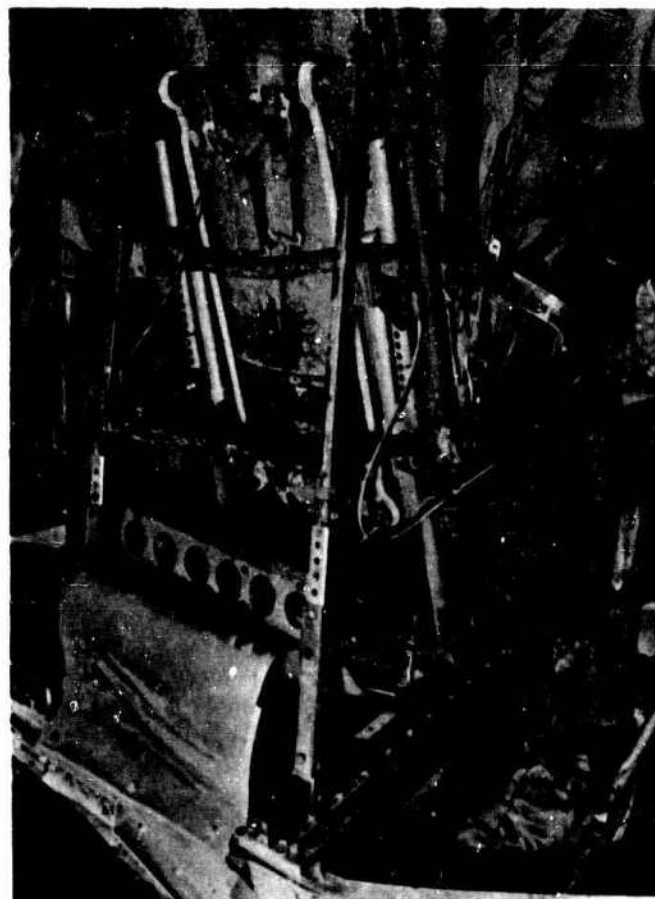
The copilot's seat remained attached to the aircraft structure, as shown in Figure 47. The seat track attachments remained intact, but the surrounding structure was badly damaged. The entire seat pan was bent upward with respect to the seat back, due to contact with forward and lower cockpit structure. The copilot dummy remained in the seat. The inertia reel was locked and the shoulder harness was still attached to the right side of the lap belt, which was still connected to the seat. The lap belt was broken on the left side of the adjustment fitting as shown in Figure 50. Neither of the vertical energy absorbers used in the seat extended. The postcrash condition of this seat is shown in Figures 48, 49, 50, and 51.

FIG. 48 RIGHT SIDE VIEW
OF COPILOT SEAT
SHOWING ANGLE
OF SEAT PAN
WITH RESPECT
TO SEAT BACK

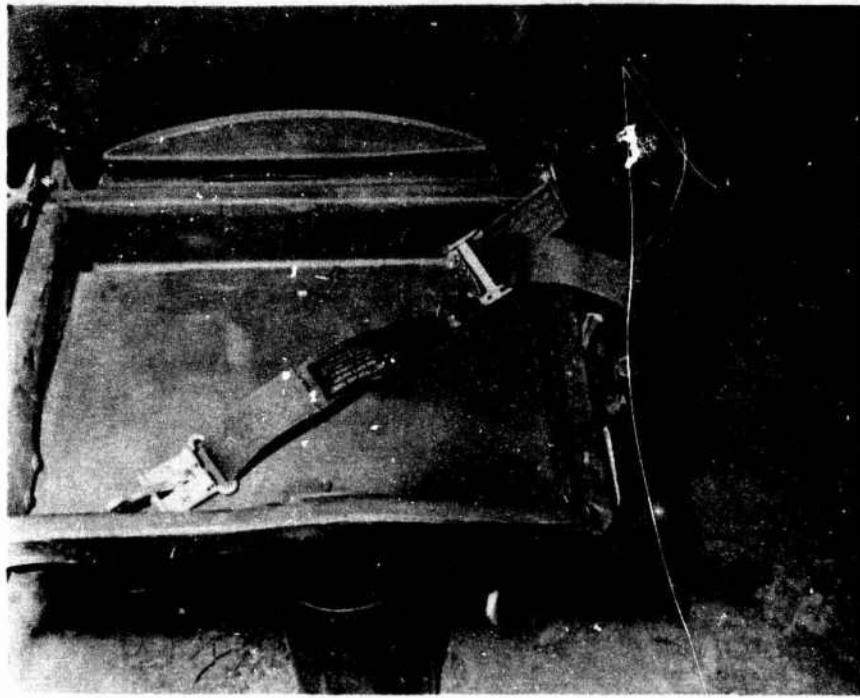
FIG. 50 VIEW OF COPILOT SEAT AFTER REMOVAL FROM WRECKAGE SHOWING SEAT PAN INDENTATION CAUSED BY CONTACT WITH OTHER STRUCTURE AND THE LAP BELT WHICH BROKE AT THE ADJUSTMENT FITTING

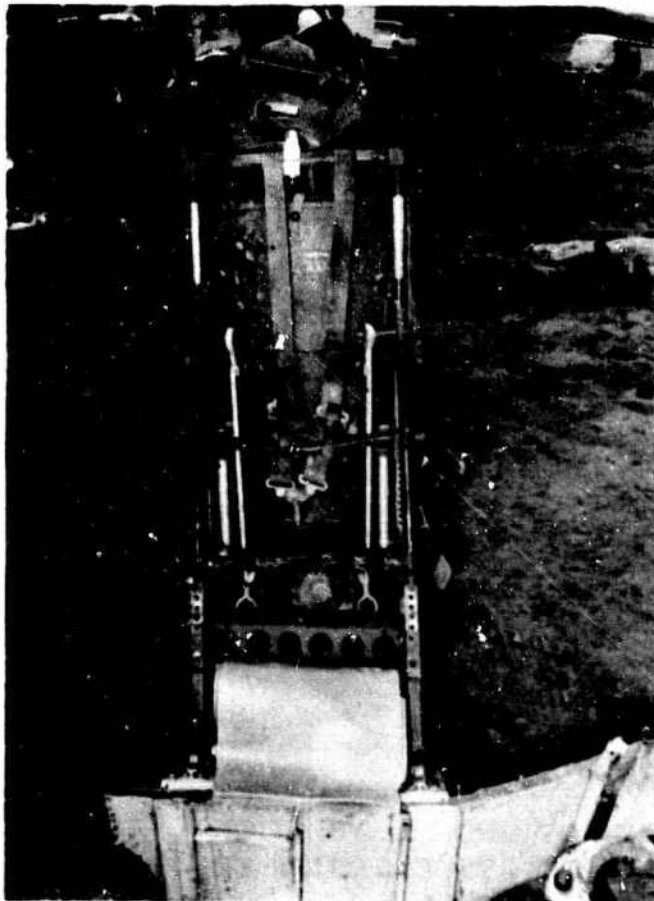
FIG. 51 REAR VIEW OF COPILOT SEAT AFTER REMOVAL FROM WRECKAGE, WITH PORTION OF FLOOR STRUCTURE STILL ATTACHED

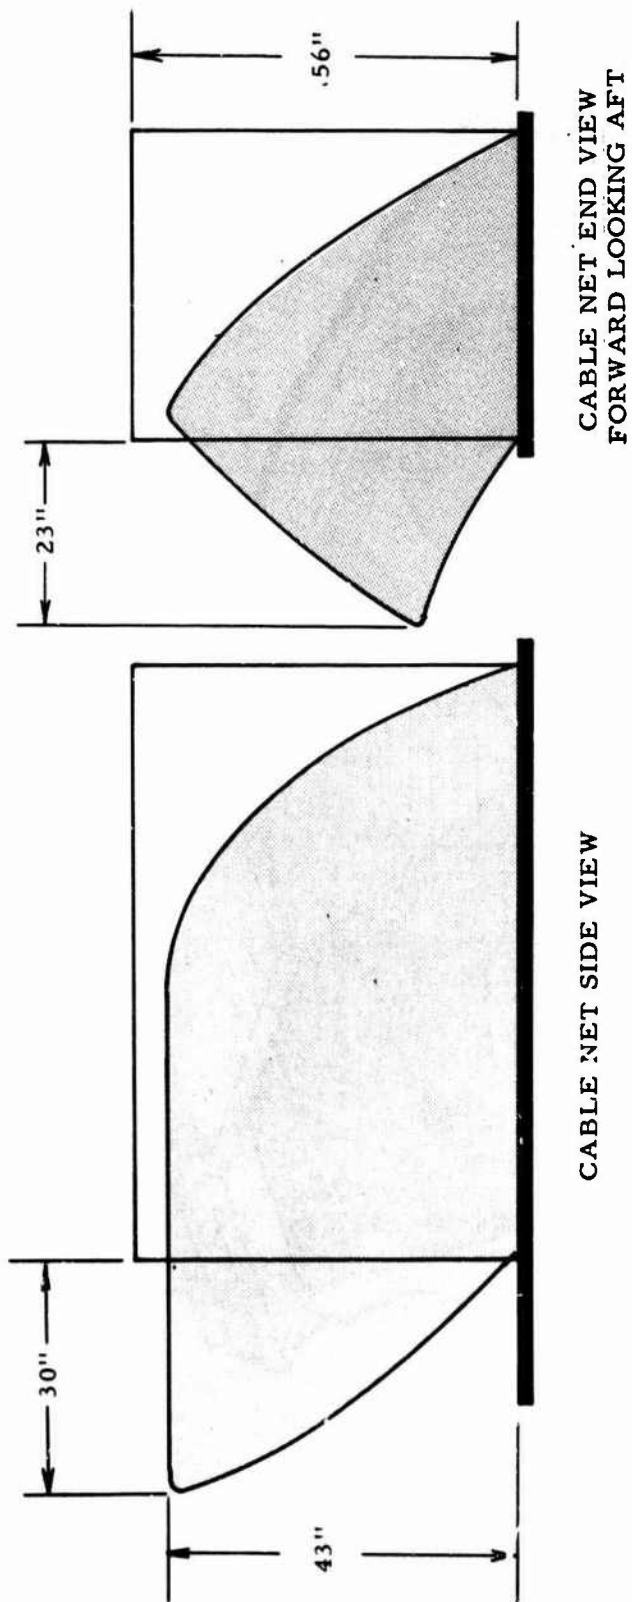
FIG. 60 POSTCRASH POSITION OF SHIFTED CARGO

net failures were found where the engine impacted the cargo. However, the cargo was "chewed up" where the engine climbed the stack. Figure 60 is a sketch of the postcrash position of the shifted forward cargo. Nearly all of the boxes of simulated cargo on the forward cargo pallet were torn apart. Of the two cargo experiments, this cargo definitely sustained the most damage.

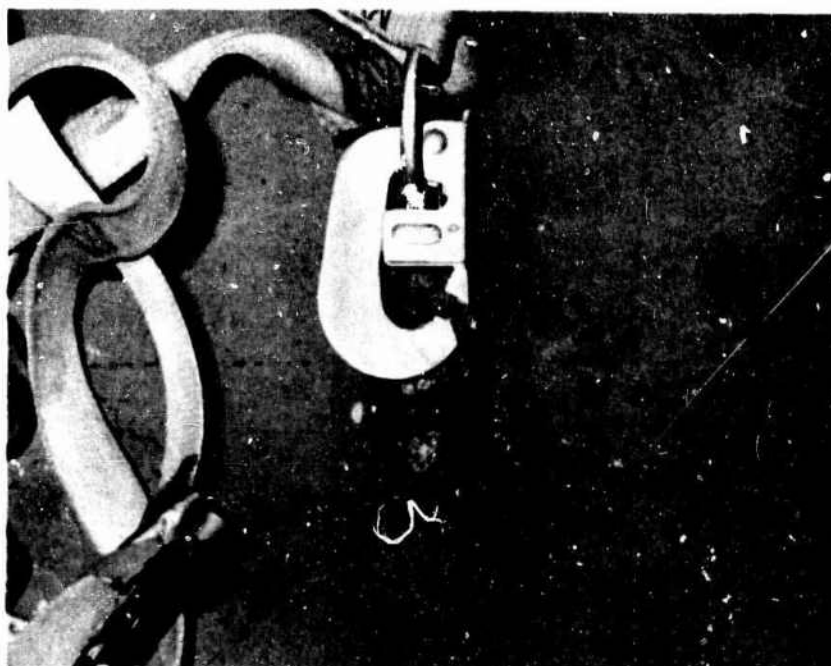
FIG. 63 FORWARD DEFORMATION OF PALLET CARGO NET
TIEDOWN RING SHOWN WITH NET HOOK STILL
ATTACHED

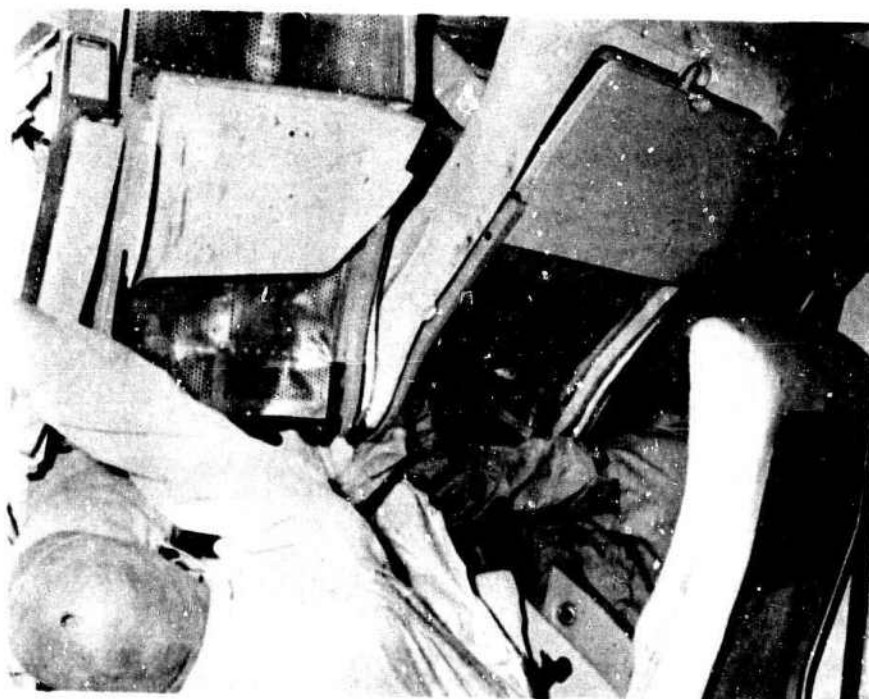
FIG. 69 VIEW SHOWING DAMAGE TO BACKS OF UN-OCCUPIED THREE PASSENGER FORWARD FACING SEATS CAUSED BY CONTACT WITH DUMMIES (PICTURE ROTATED 90° CLOCKWISE)

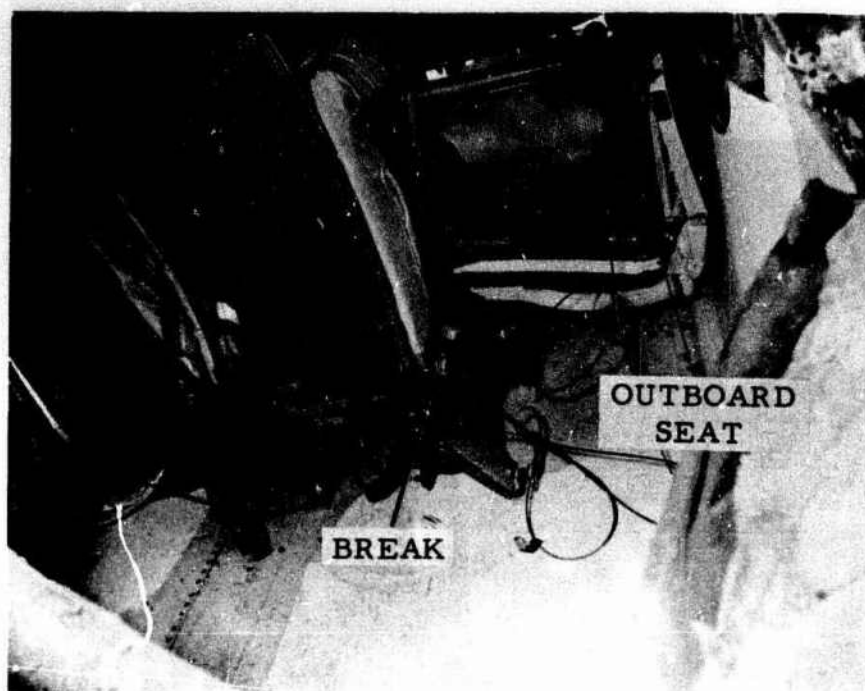
FIG. 70 POSTCRASH VIEW OF OCCUPIED THREE PASSENGER FORWARD FACING SEATS LOOKING FORWARD, SHOWING FORWARD ROTATION OF SEAT NEXT TO WALL

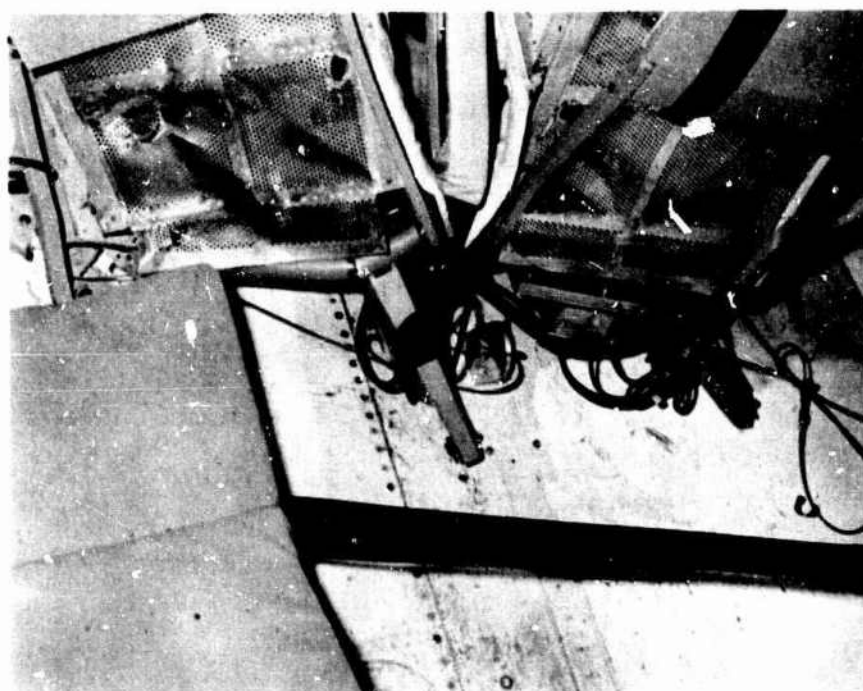
FIG 71 REAR VIEW OF AISLE AND CENTER OCCUPIED THREE PASSENGER FORWARD FACING SEATS SHOWING FAILURE OF LATERAL TUBE THAT ALLOWED AISLE SEAT TO DEFLECT DOWNWARD TOWARD AISLE (PICTURE ROTATED 90° CLOCKWISE)

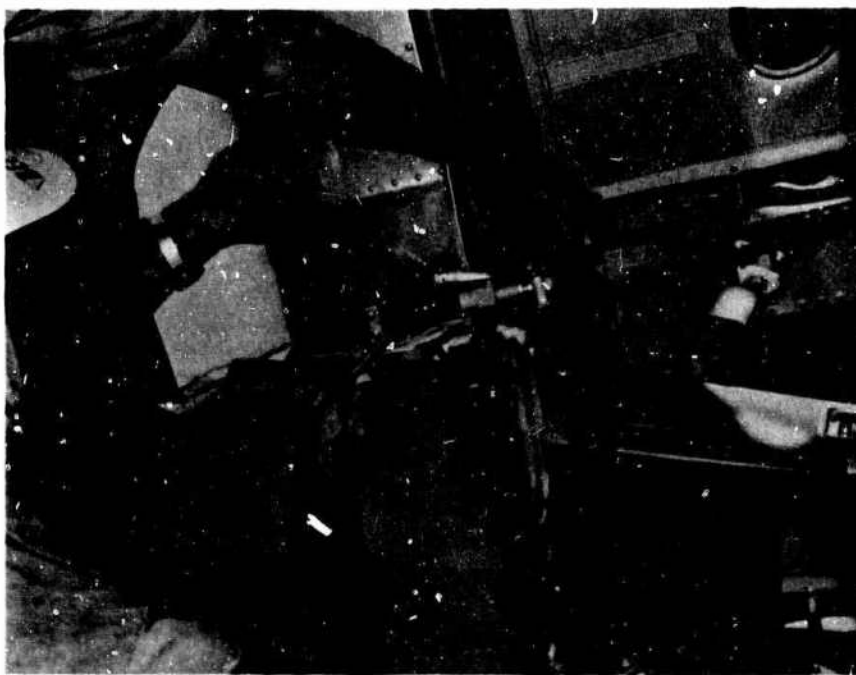
FIG. 79 EXAMINATION OF REARWARD FACING SEAT BACK LOCKS AFTER CRASH

All three seat back locks failed during the crash, causing the backs to collapse and allowing the seat occupants to slide out of the seats,

although all three lap belts remained fastened. The three seat back locks, small hydraulic cylinders, all failed in a similar manner - at the point indicated in Figure 79. The seat leg to floor attachments held throughout the crash and the energy absorbers located in the aft legs were attenuated. The general condition of the seat is shown in Figures 77 and 78.

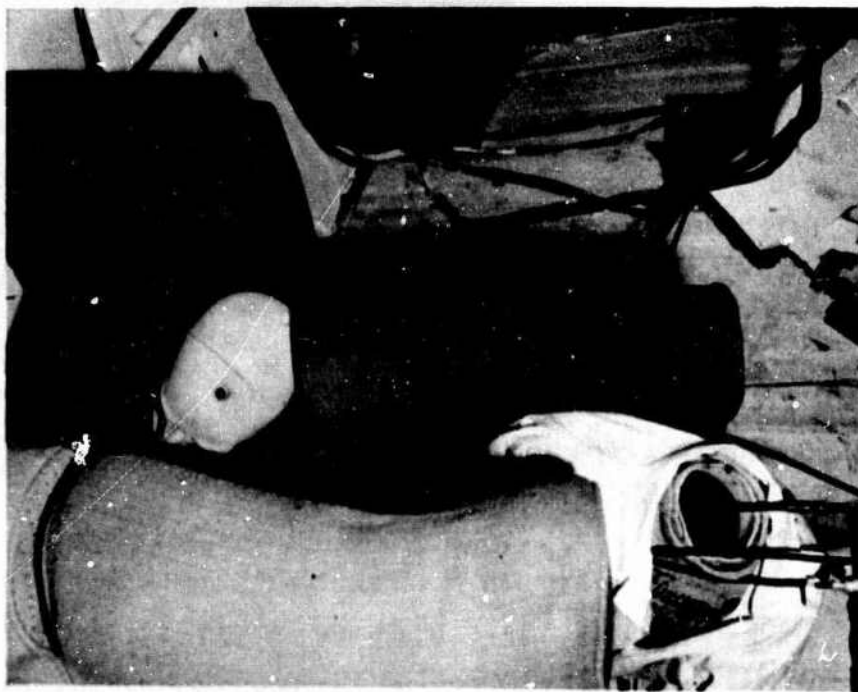
FIG. 91 HEAD LOSS EXPERIENCED BY AISLE DUMMY, LOOKING
DOWN ON THE SEAT AND DUMMIES
(PICTURE ROTATED 90° COUNTERCLOCKWISE)

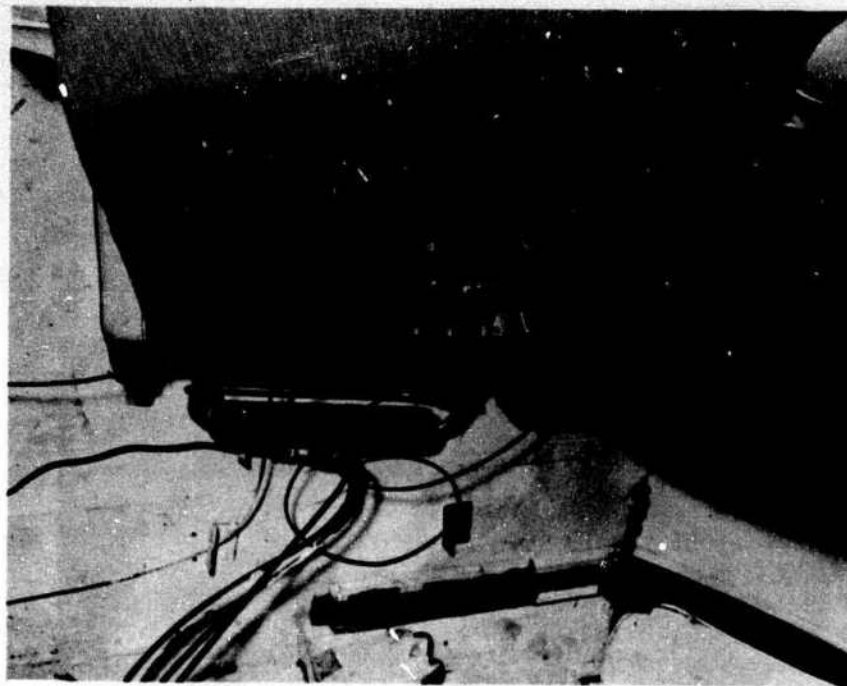
FIG. 92 SEAT BACK SEPARATION IN AISLE SEAT
